Name Of Dam: LAKE COHOON DAM
Location: CITY OF SUFFOLK
Inventory Number: VA. 12301

PHASE I INSPECTION REPORT NATIONAL DAM SAFETY PROGRAM

AUGUST 1979

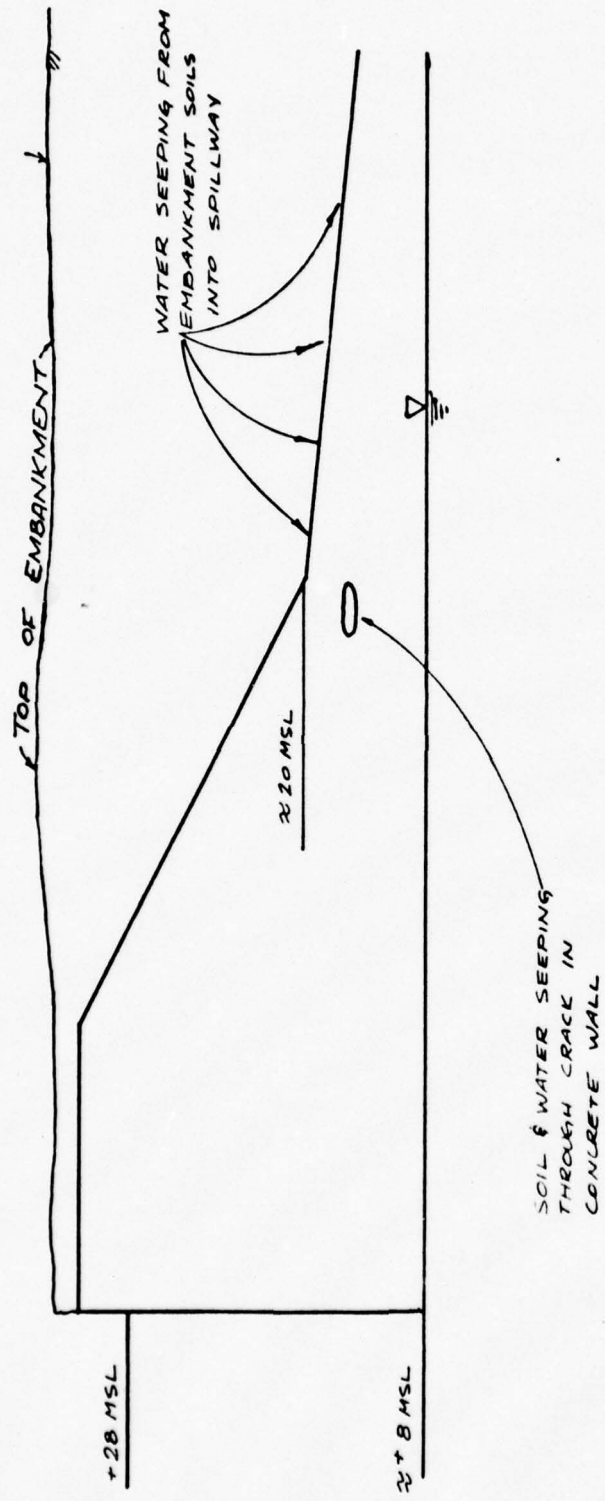
OBSERVED SEEPAGE	LAW ENGINEERING TESTING COMPANY GEOTECHNICAL & ENVIRONMENTAL CONSULTANTS 7913 WESTPARK DRIVE, MCLEAN, VIRGINIA 22101			
LAKE COHOON DAM	SCALE	Drawn: Checked:	DLR MJC	Job No. W-9-2279
	NONE	Date:	6-12-79	PLATE NO. 6
NANSEMOND COUNTY, VIRGINIA

3.1.4 Abutments: The abutment walls show white stains, spalling, and actual seepage. At the left abutment wall, about 4 feet downstream from the end of the slope wall, there is a joint showing seepage of less than 1 GPM accumulation of mud and small roots. The abutment walls showed signs of spalling and reinforcing bars were visible in some locations.

SCHEMATIC OF NORTH SIDE OF SPILLWAY
